UNDERWATER BRIDGE INSPECTION REPORT

STRUCTURE NO. 5816

RED RIVER OF THE NORTH

MINNESOTA DEPARTMENT OF TRANSPORTATION
UNDERWATER BRIDGE INSPECTION

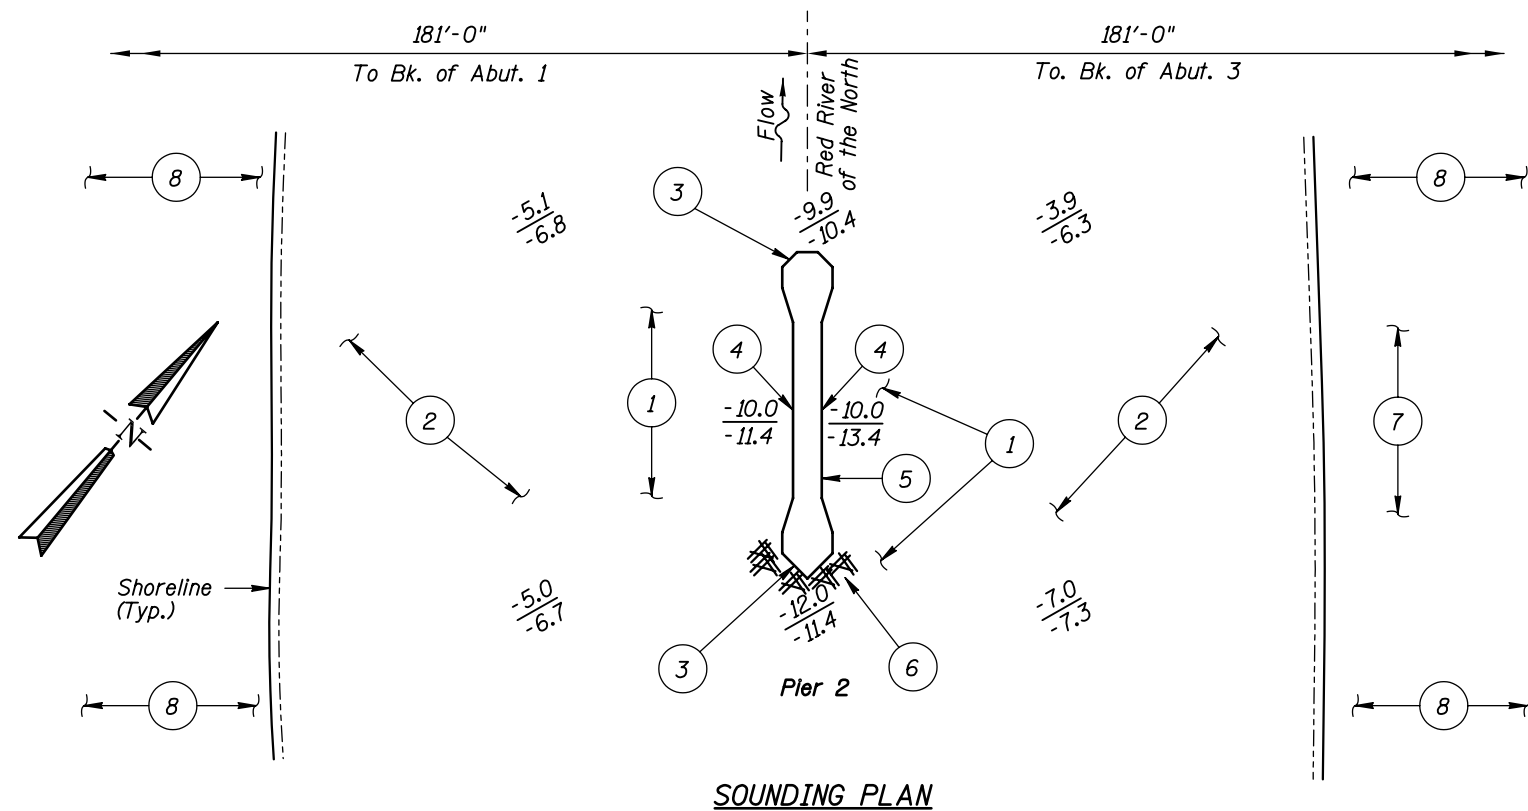
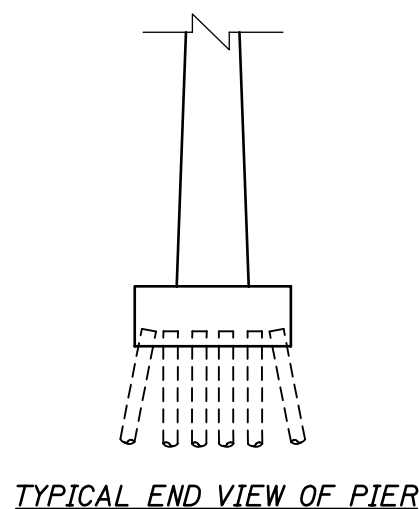
INSPECTION AND SOUNDING PLAN

- The channel bottom material around the pier shaft consisted of gravel with up to 2 inches of probe rod penetration.
- The channel bottom material consisted of silt with up to 1 foot of probe rod penetration.

- Light scaling was observed at the pier noses from 1.5 feet above the waterline to 0.5 feet below the waterline with a maximum penetration of 1/8 inch.

- A hairline crack was observed at the midpoint of Pier 2 on both sides, extending from 11 feet above the waterline to 2 feet below the waterline.
- Formed openings, measuring 8 inches wide by 8 inches high, were observed along Pier 2 at 6.5 feet below the waterline at 1/4 point intervals.

- Timber debris consisting of 6 to 8 inch diameter branches was observed around the upstream nose of the pier, extending approximately 8 feet out from the pier shaft and approximately 3 feet above the channel bottom.

- The east bank exhibited heavy erosion that extended back to the East Abutment and the abutment exhibited undermining with exposed piling.
- Heavy bank erosion was observed along the banks of the channel upstream and downstream of the bridge.

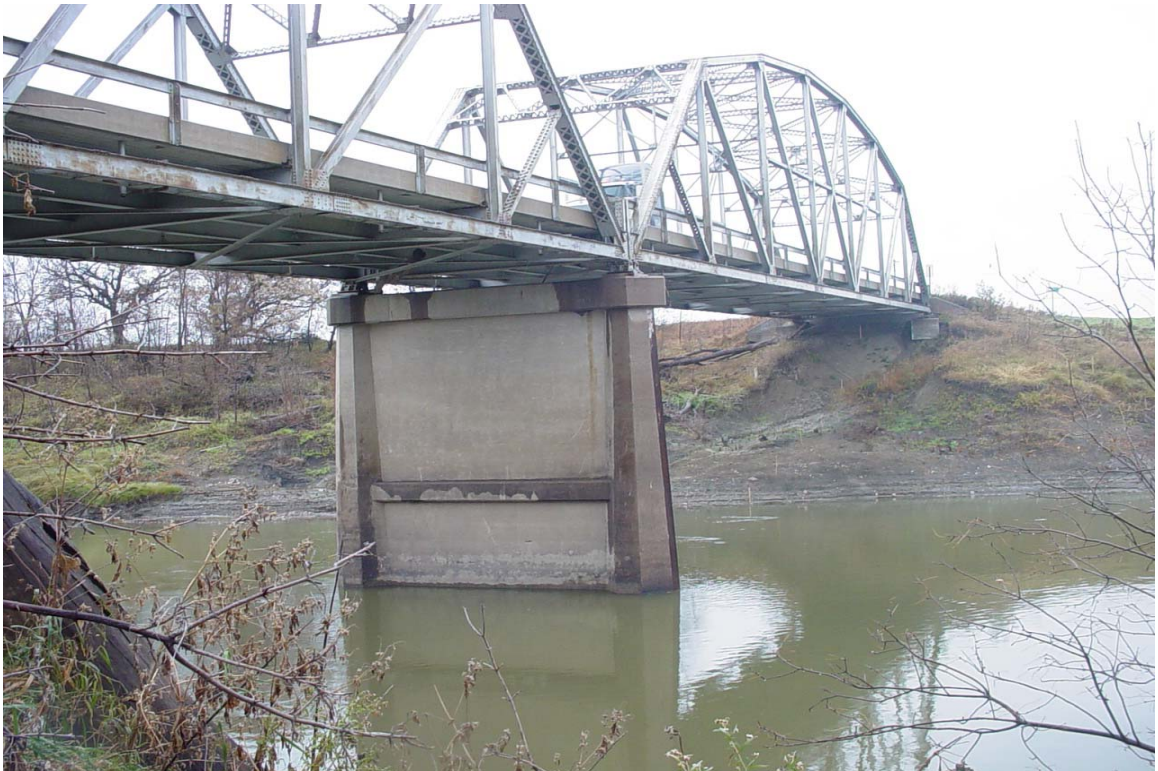
Photograph 2. View of Pier 2, Looking North.

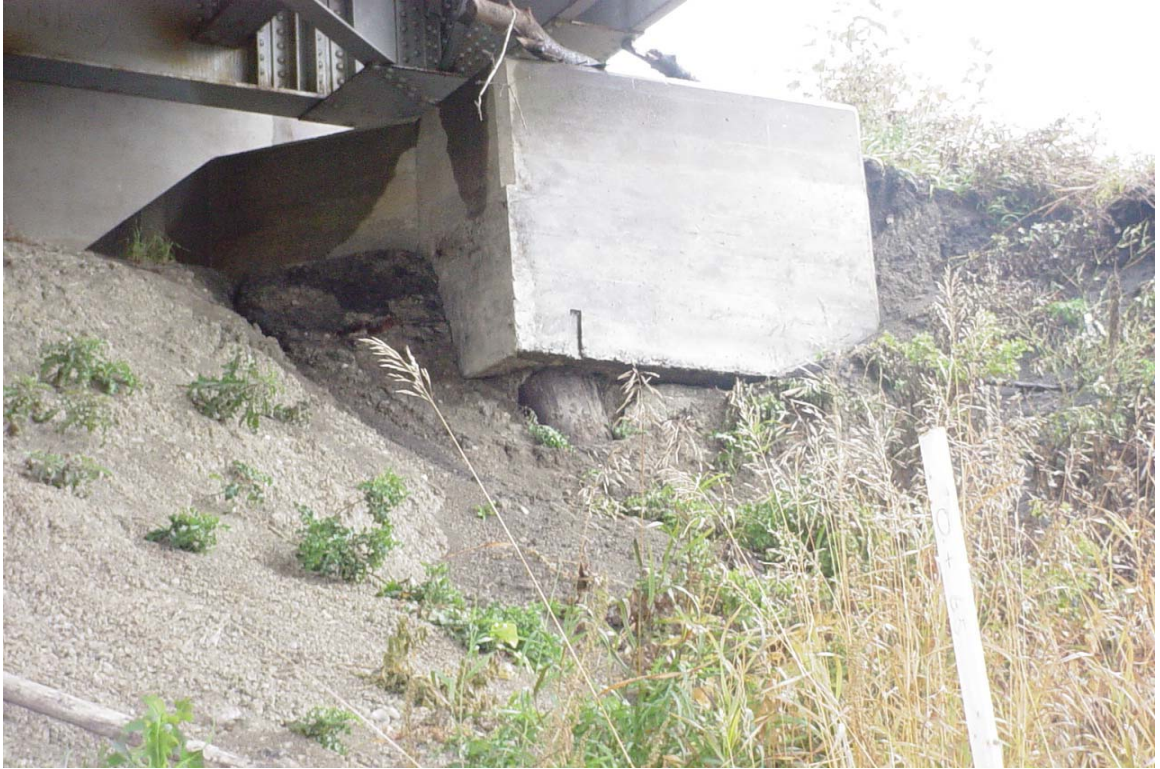
Photograph 3. View of the Undermining at the East Abutment, Looking East.

- (A) Monitor the erosion at the East Abutment during future routine and underwater inspections, and if found to be increasing in the future, repair operations may become warranted.
- (B) Reinspect the submerged substructure unit at the normal maximum recommended (NBIS) interval of five (5) years.

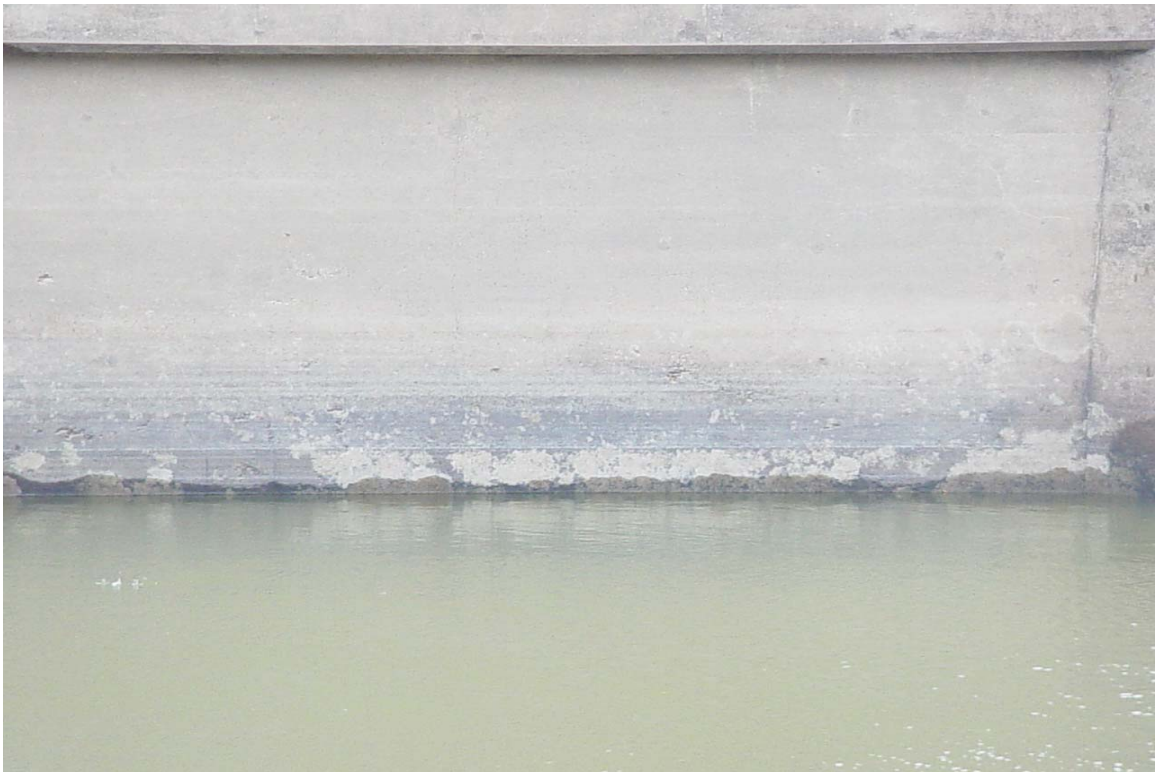
Photograph 4. View of Pier 2 at the Waterline, Looking Southwest.

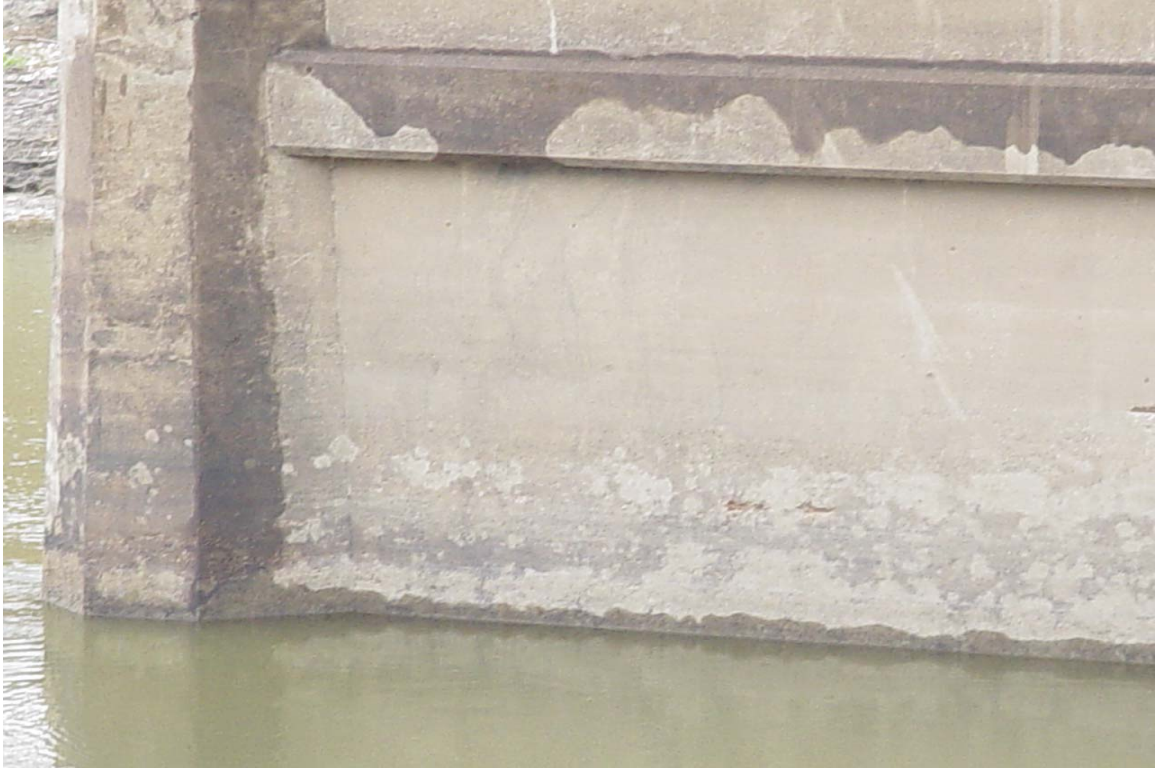
Photograph 5. View of the Downstream Nose of Pier 2, Looking North.
